# Structural Repair and Protection Cost Estimate and Attendant Condition Appraisal of the Miami Marine Stadium

Miami, FL  
January 2010

SGH Project 090457

Project 090457.00 – Structural Repair and Protection Cost Estimate and Attendant Condition  
Appraisal of the Miami Marine Stadium, Miami, FL

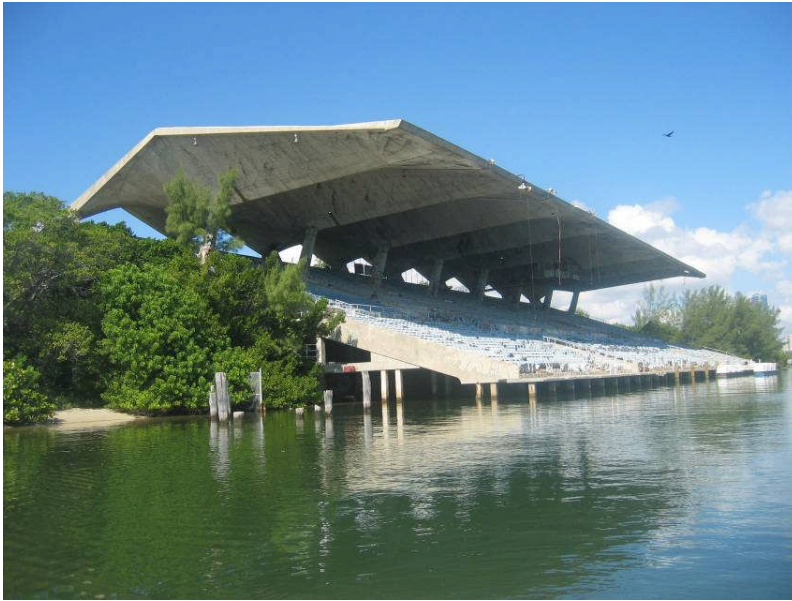
**Photo 1**

Overall view of the Miami Marine Stadium.

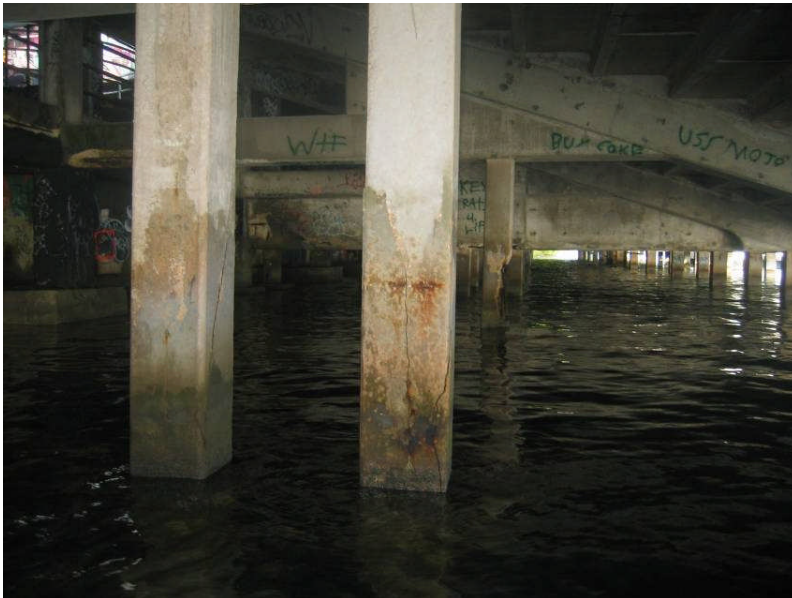
**Photo 2**

- Several piles below the lower seating area show moderate to severe deterioration (Photos 2 and 3). There is a pile showing severe deterioration below the water level (Photo 4).
- At our direction SPS attempted to excavate and dewater an inspection pit at the back of one of the pile caps supporting the main columns that support one of the roof segments. Our intent was to examine and sample one or more piles that are not otherwise exposed to view. It was not possible to accomplish the dewatering using conventional heavy-duty submersible pumps, and consequently, we had to abandon this inspection and sampling.

Piles showing moderate deterioration.

- Repair delaminated and spalled concrete on exposed piles.
- Install new piles to supplement deteriorated exposed piles.

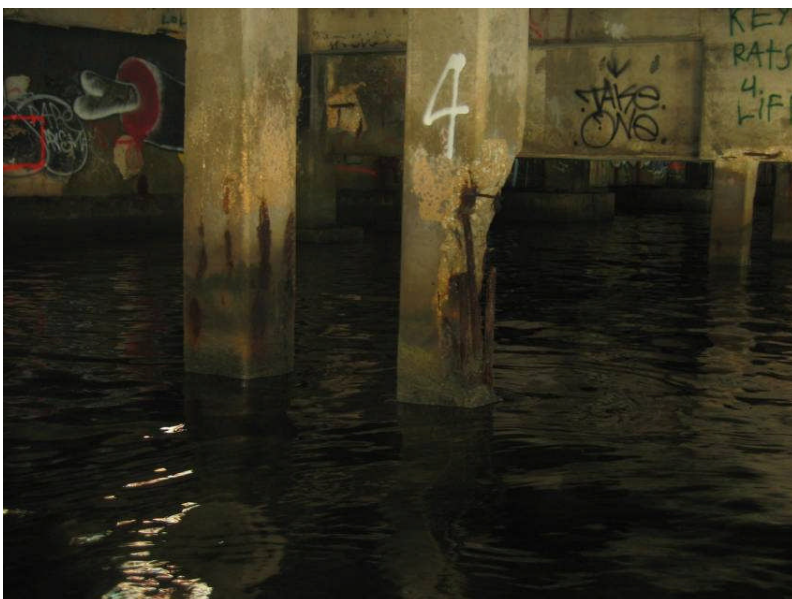
**Photo 3**

Piles showing severe deterioration with section loss.

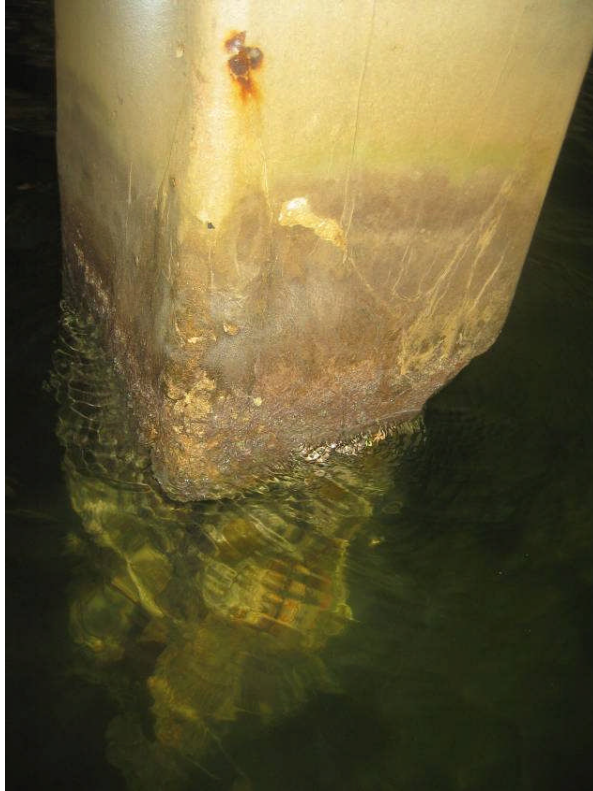
**Photo 4**

Pile with severe deterioration below the water level.

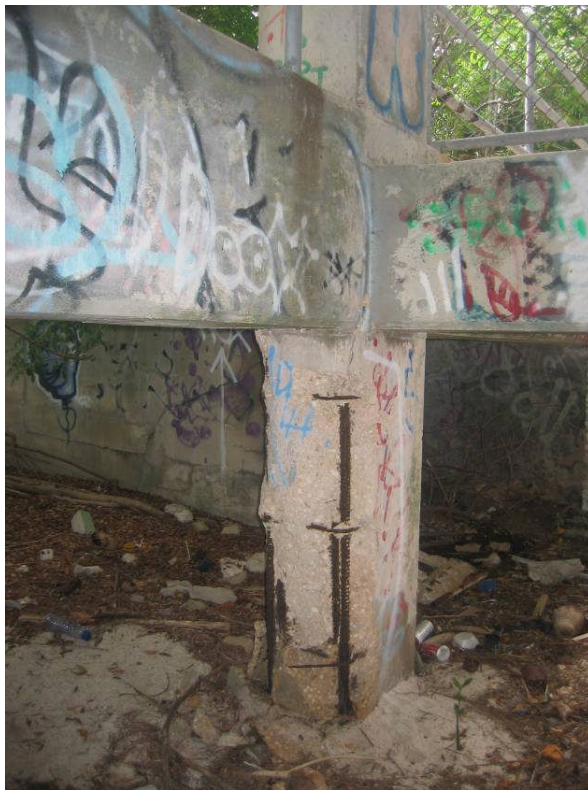
**Photo 5**

- Some columns and beams at the exposed areas between Line 1 and 2 and Lines 16 and 17 show severe deterioration (Photos 5 and 6).
- The seawall along Line D shows areas of severe deterioration (Photos 7 and 8). The concrete cores revealed deeper deterioration which was not detectable using sounding techniques (Photo 9).
- The top sides of the ground level slabs show minor deterioration (Photo 10). At two locations we observed through openings in the slab, the underside side of the slabs and the grade beams are free of distress and deterioration (Photo 11).

Column at open area with large spalls.

- Repair delaminated and spalled concrete on the seawall.
- Repair delaminated and spalled concrete on the topside of the slabs.
- Repair delaminated and spalled concrete on columns.
- Remove and replace severely deteriorated beams, slabs and columns.

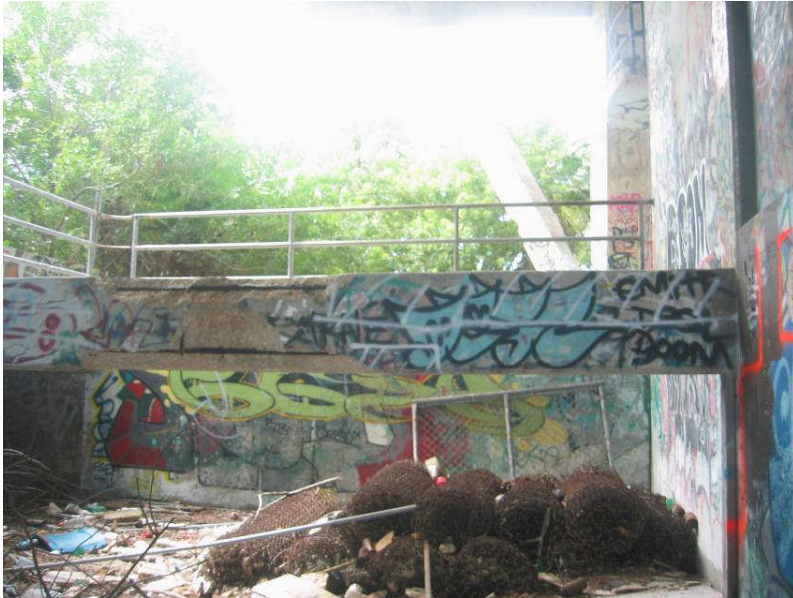
**Photo 6**

Beam at open area with large spalls.

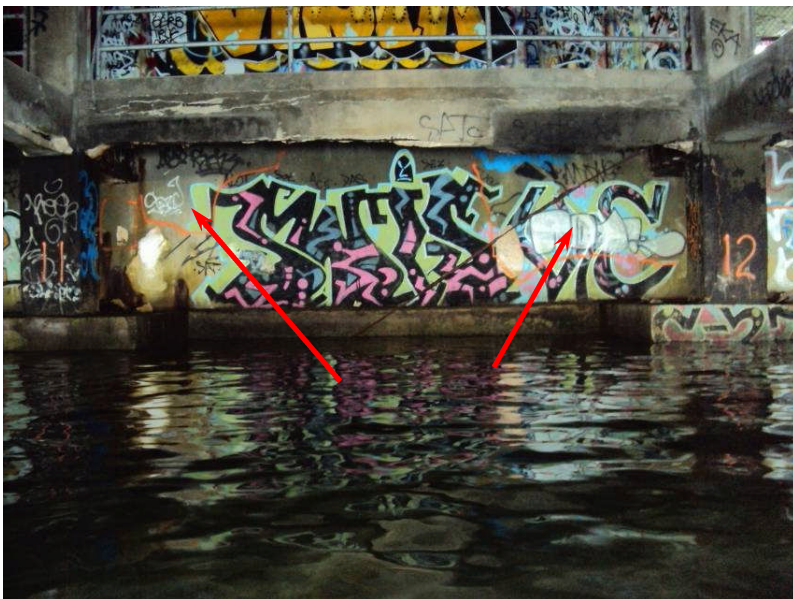
**Photo 7**

Seawall section with delaminated areas. Extent of delamination is bounded by the orange paint.

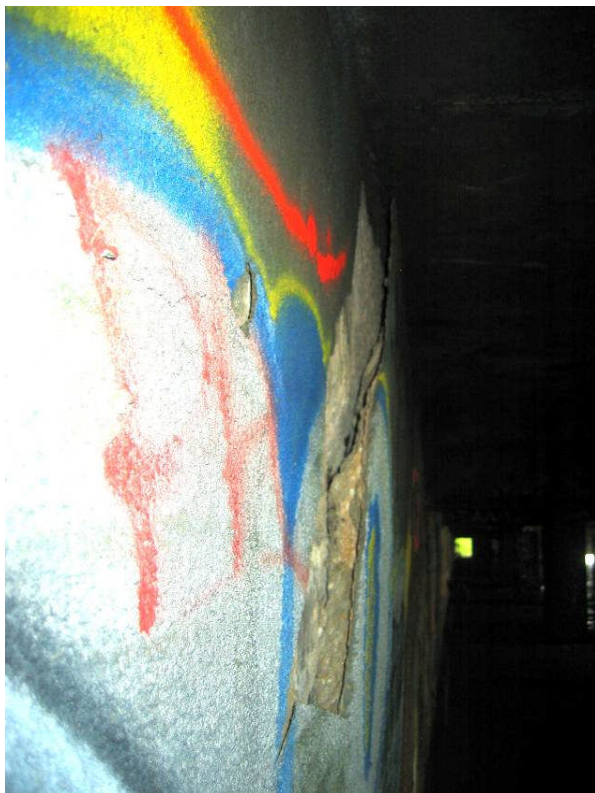
**Photo 8**

Delamination in seawall.

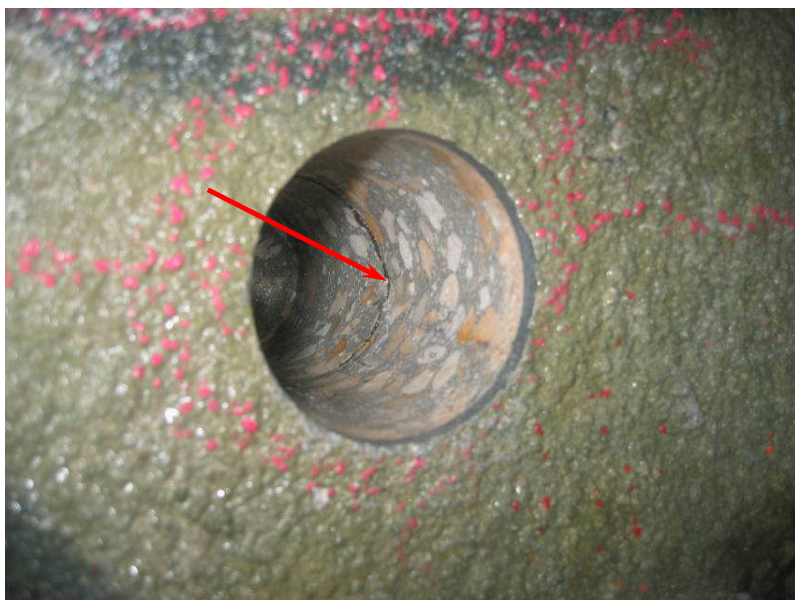
**Photo 9**

Internal crack in seawall  
caused by corrosion of  
reinforcement.

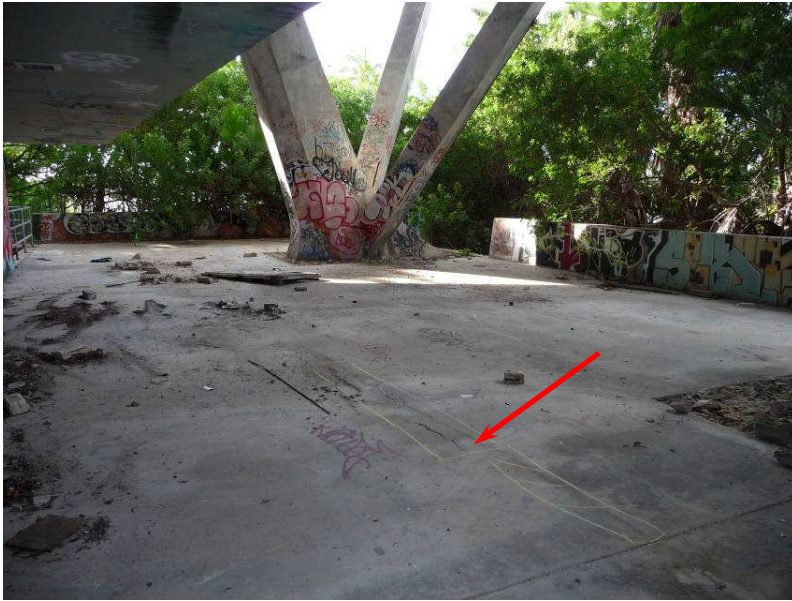
**Photo 10**

Deterioration on topside ground level slab.

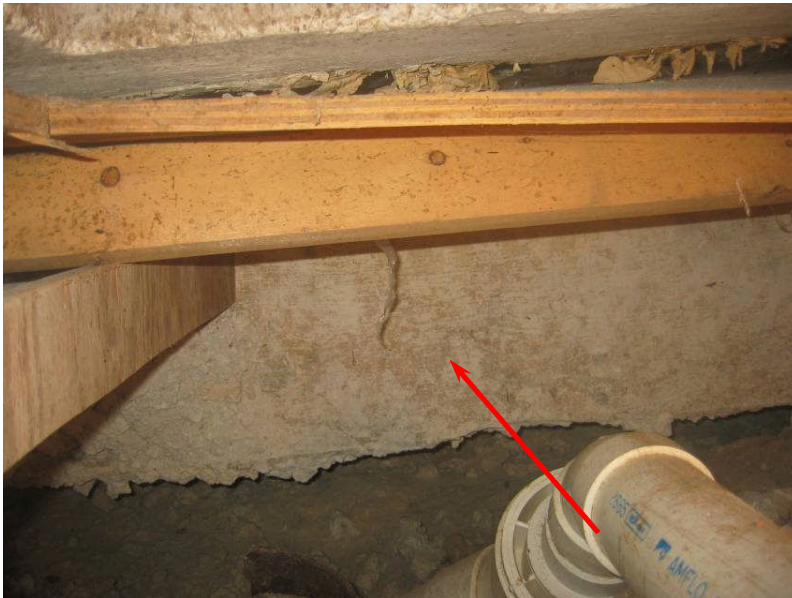
**Photo 11**

Grade beam in good condition.

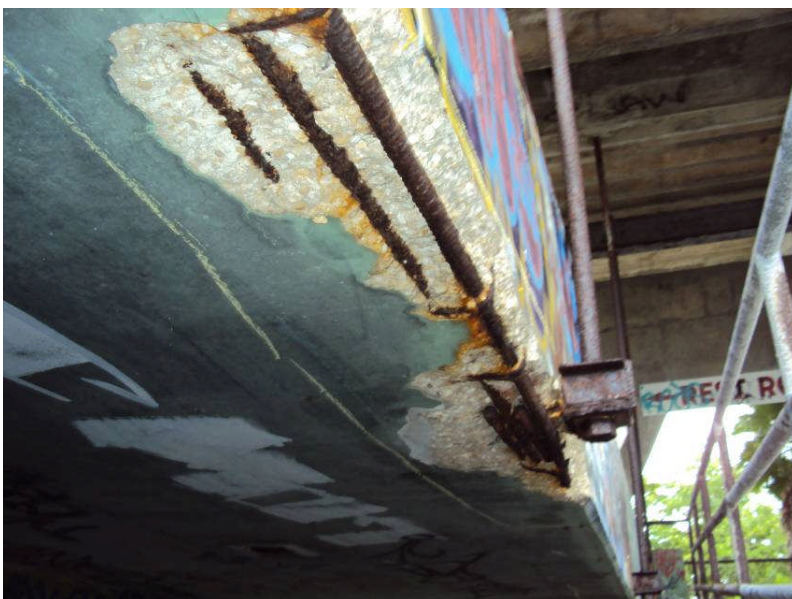
**Photo 12**

- The steel hangers supporting the mezzanine slab and adjacent concrete show severe deterioration (Photo 12).
- The ramp and mezzanine slabs show moderate deterioration with localized spalls or delaminations (Photos 13 and 14)

Deterioration at hanger location.

- Repair delaminated and spalled concrete on the topside, underside and edges of the slabs.
- Replace deteriorated steel hangers and connectors supporting the mezzanine slab.

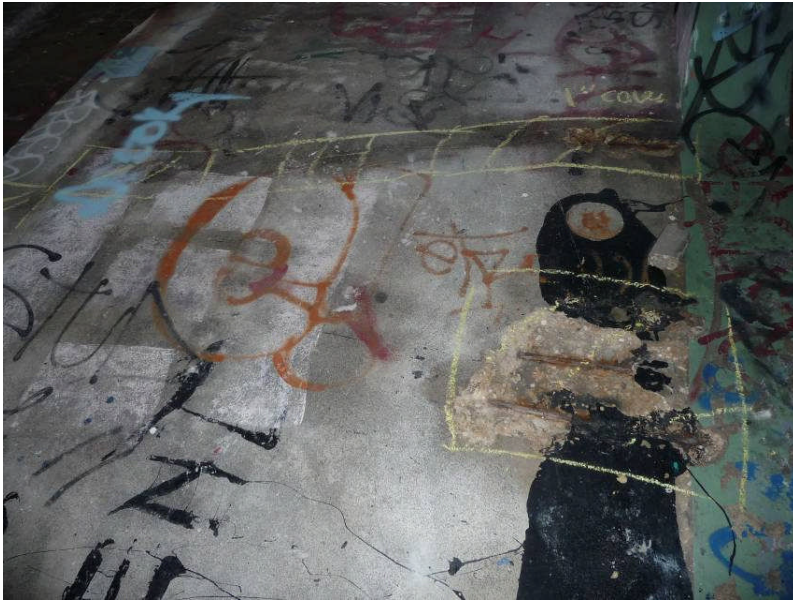
**Photo 13**

Deterioration on topside of ramp slab.

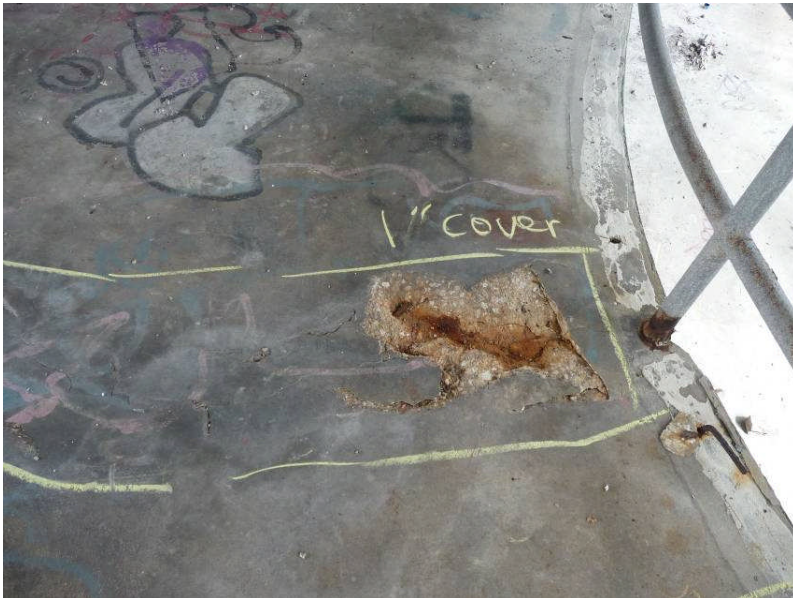
**Photo 14**

Deterioration on topside of mezzanine slab.

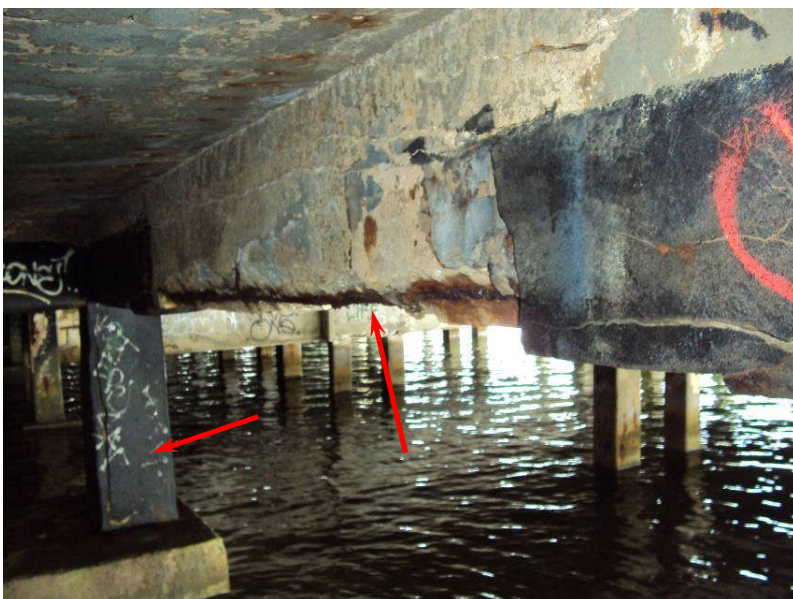
**Photo 15**

- The over-water concrete elements (slabs, beams and columns) between Line D and E, and beams north of Line E show severe deterioration (Photos 15 and 16).
- The topside and underside of the seating areas show moderate deterioration with localized spalls or delaminations (Photos 17 and 18).
- Some seating slabs have cracks above the raker beams (Photo 19). The crack widths we measured range between 0.011 in. and 0.020 in. The majority of the cracks are about 0.016 in.
- The slab north of line J has also cracks on the topside. The crack widths range between 0.011 in. and 0.050 in. The majority of the cracks are about 0.020 in.
- The grout plugs at some seating anchor locations are missing or deteriorated due to anchor corrosion (Photo 20).

Beam and column along column line E showing severe deterioration.

- Repair delaminated and spalled concrete on the topside and underside of the seating slabs.
- Repair delaminated and spalled concrete on beams.
- Remove and replace severely deteriorated beams, slabs and columns.
- Repair delaminated and spalled concrete on vomitory and parapet walls, and roof diaphragm.
- Fill cracks wider than 0.012 in. in grandstands beams by epoxy injection.
- Replace delaminated parging on walls and columns.
- Install sealant in existing seating anchor pockets with missing grout plugs. Remove debonded or cracked grout and install sealant.

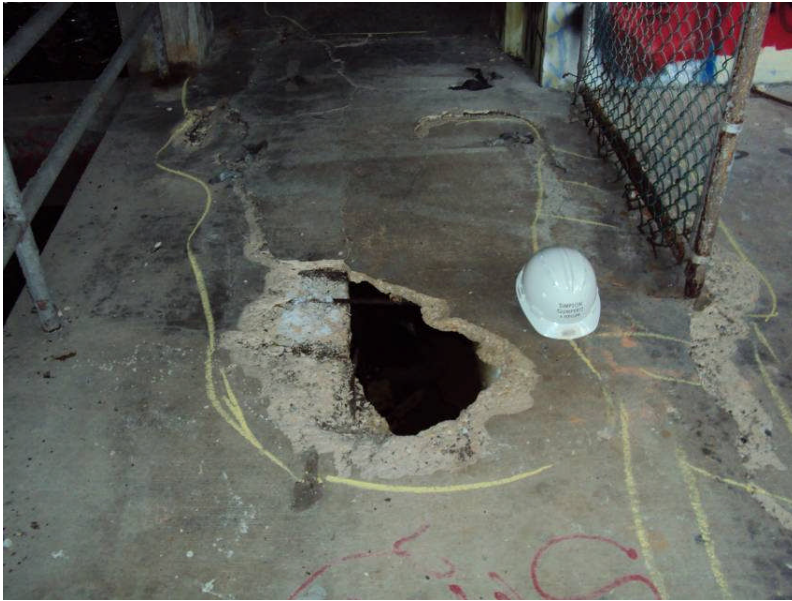
**Photo 16**

Slab showing severe deterioration.

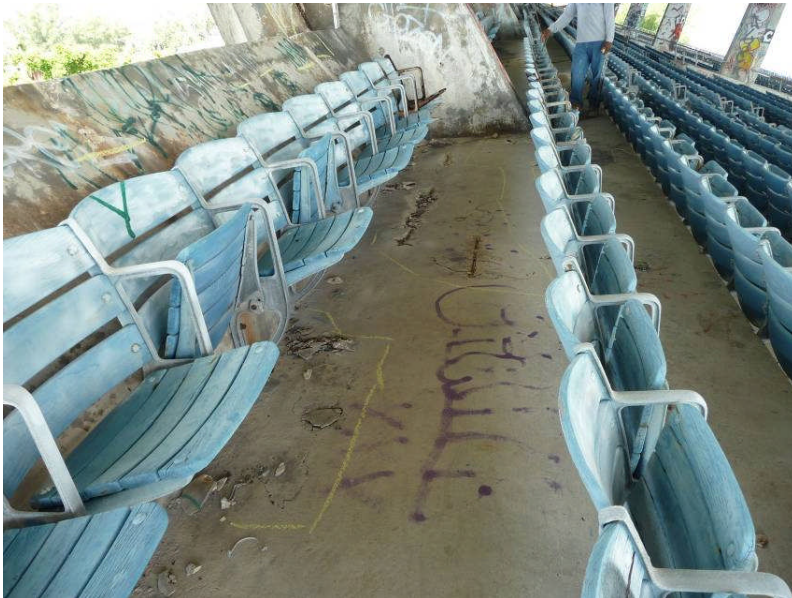
**Photo 17**

Deterioration on the topside of seating slab.

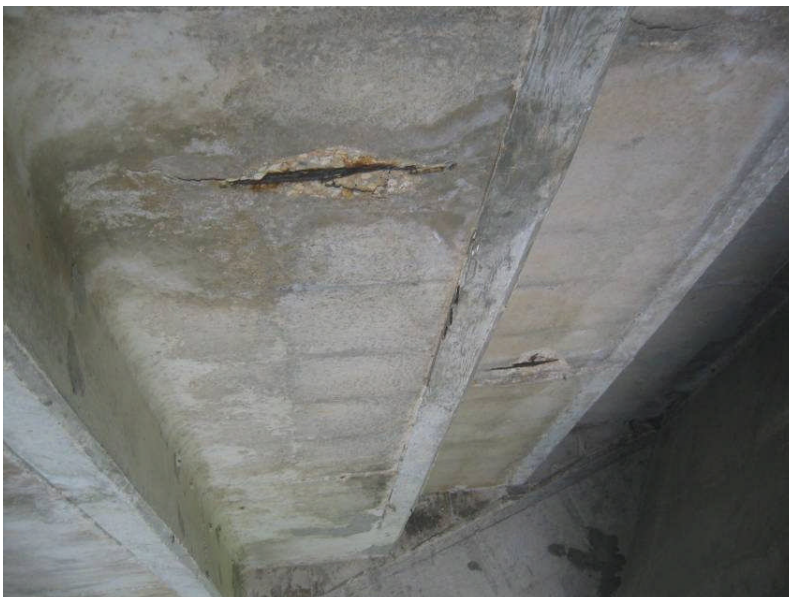
**Photo 18**

Deterioration on the bottom side of seating slab.

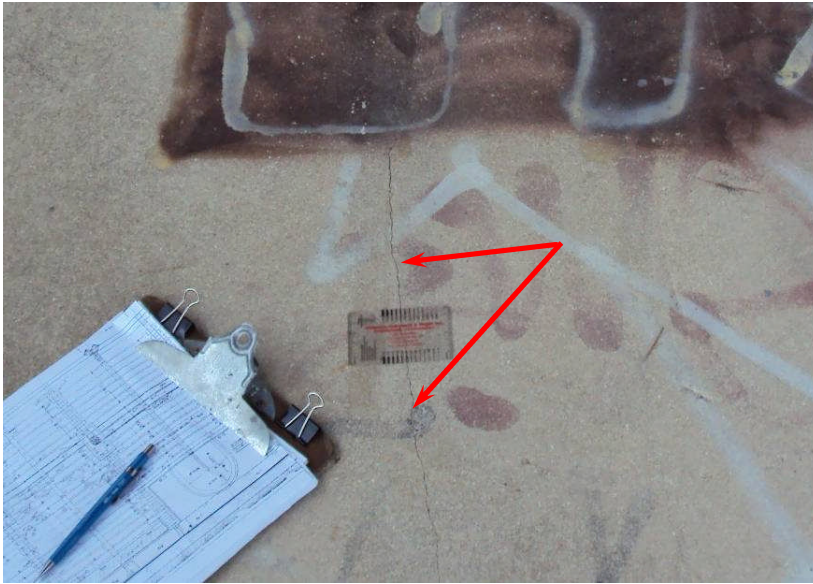
**Photo 19**

Crack on top side of seating slab.

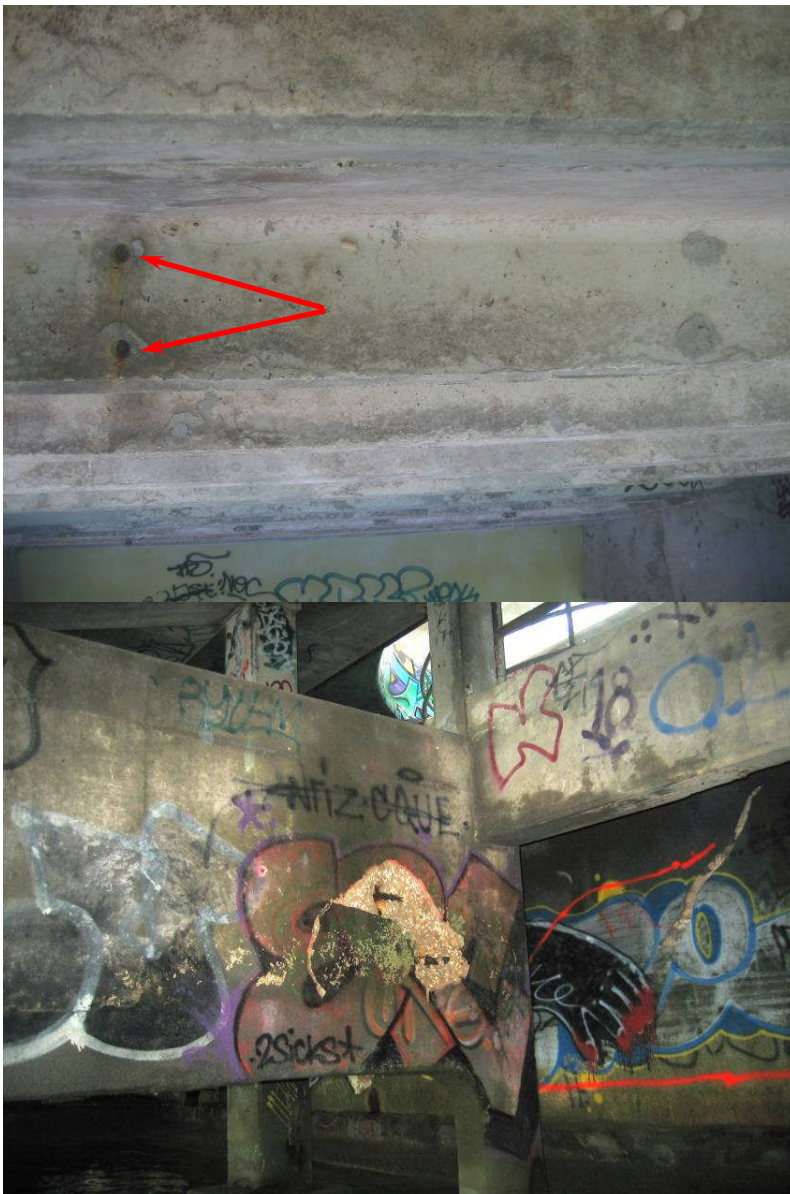
**Photo 20**

- The vomitory and parapet walls in general show moderate deterioration with localized spalls or delaminations (Photos 21 and 22). Several parapets around the slant front columns show severe deterioration (Photo 23).
- The raker beams supporting the seating structure show moderate deterioration with localized spalls or delaminations (Photo 24). The beams next to the uppermost seating row shows severe deterioration localized at the beam upper region (Photo 25).

Grout plugs missing on risers.

Spall on vomitory wall.

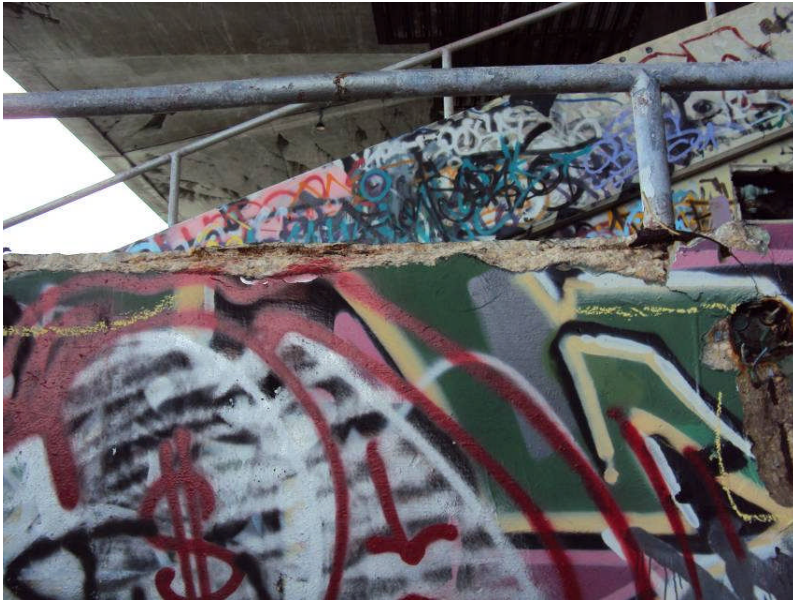
**Photo 22**

Deterioration on upper portion of parapets.

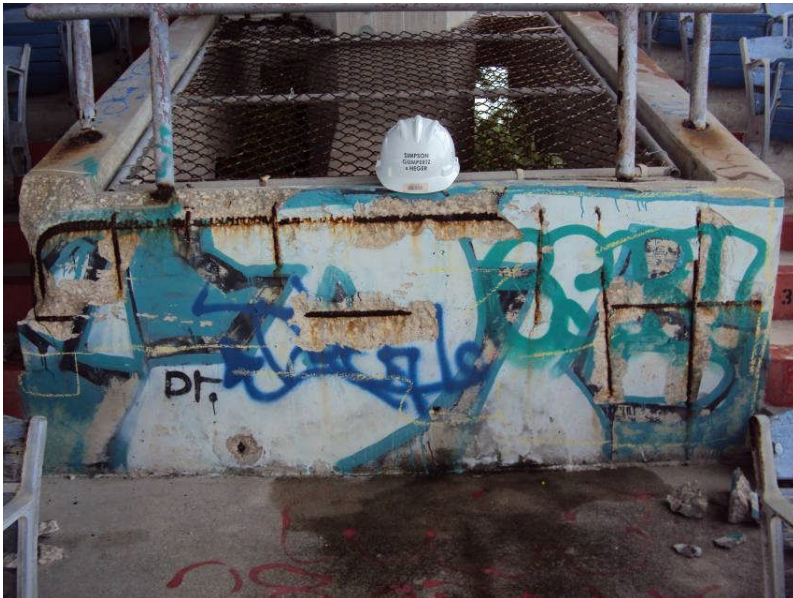
**Photo 23**

Severe deterioration on parapets around front slanted columns.

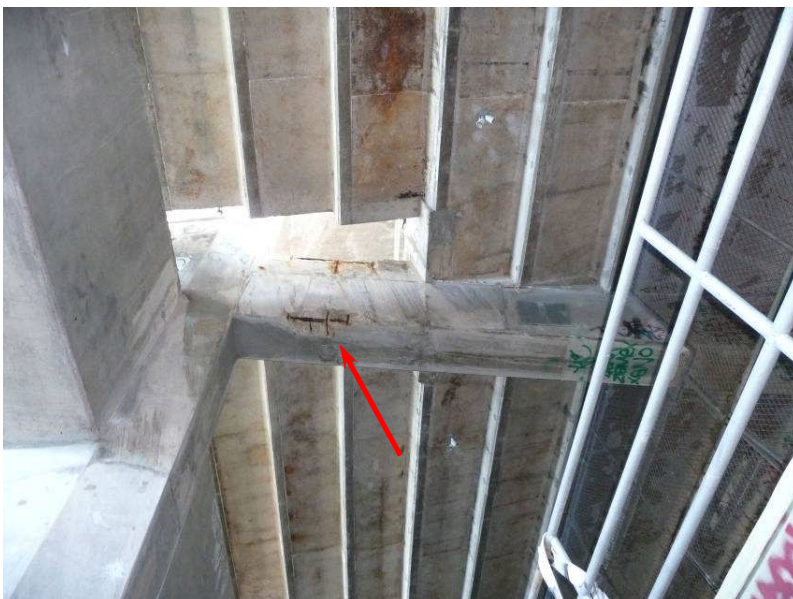
**Photo 24**

Moderate deterioration on raker beam.

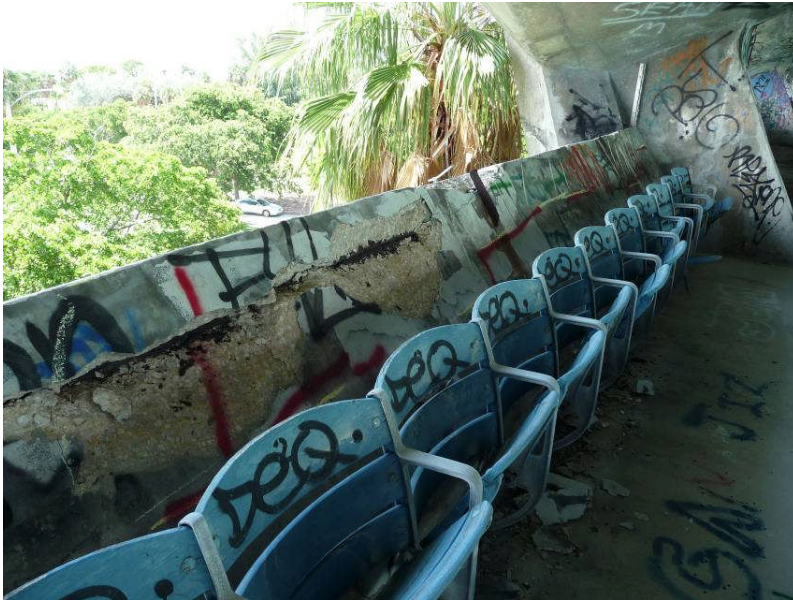
**Photo 25**

Severe deterioration on beams next to the uppermost seating row.

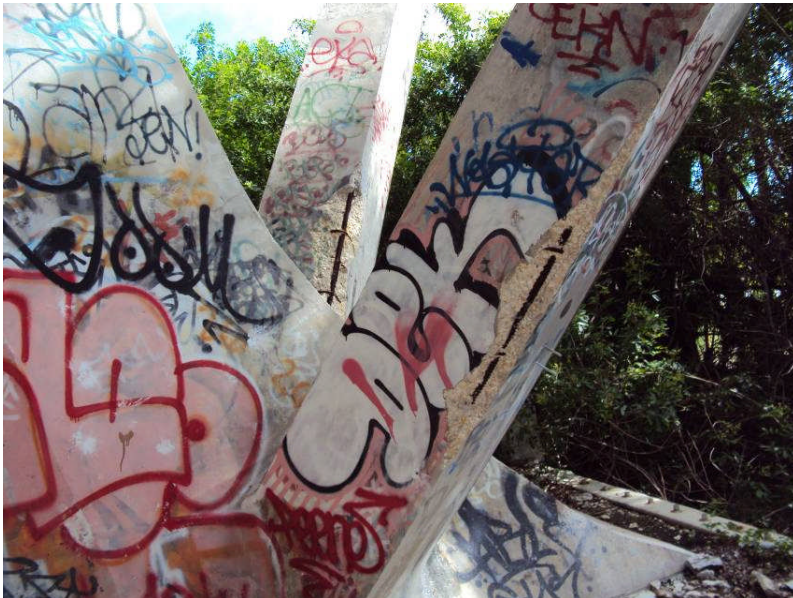
**Photo 26**

- The inclined columns show moderate deterioration with localized spalls or delaminations (Photos 26 and 27).
- The topside and underside of the roof structure shows moderate deterioration with localized spalls or delaminations (Photos 28 and 29).
- The roof shows diagonal cracking throughout the front cantilever portion (Photos 30 and 31). The crack widths we measured range between 0.013 in. and 0.040 in. The majority of the cracks are about 0.020 in.
- Some post-tensioning anchorage zones of the roof diaphragm are spalled or delaminated (Photo 32).

Deterioration on back slanted columns.

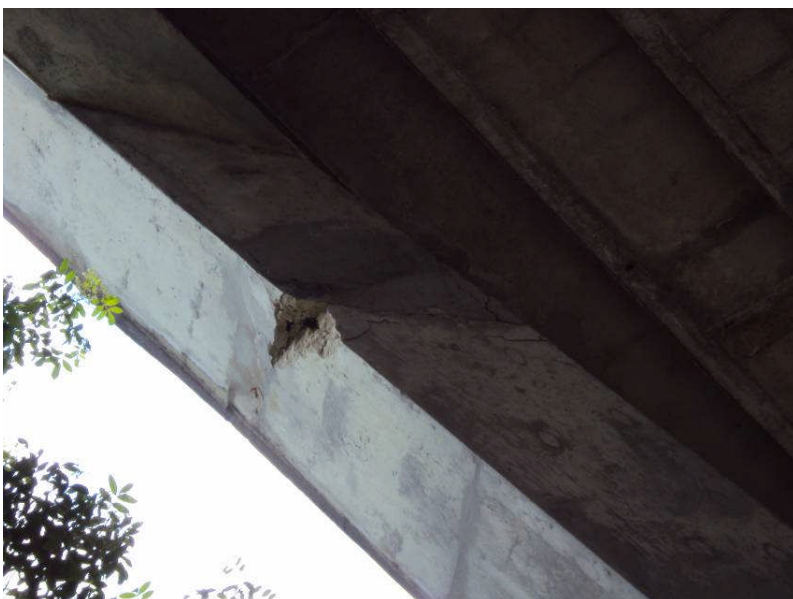
**Photo 27**

Deterioration on front slanted columns.

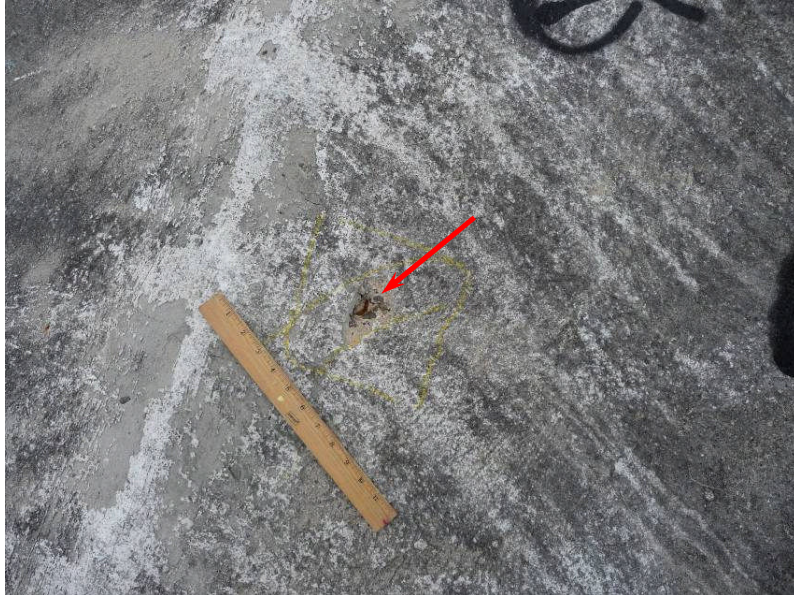
**Photo 28**

Typical spall on top side of roof hypars.

- Repair delaminated and spalled concrete on the topside and underside of the roof and wall diaphragm.
- Fill cracks in the roof by epoxy injection.

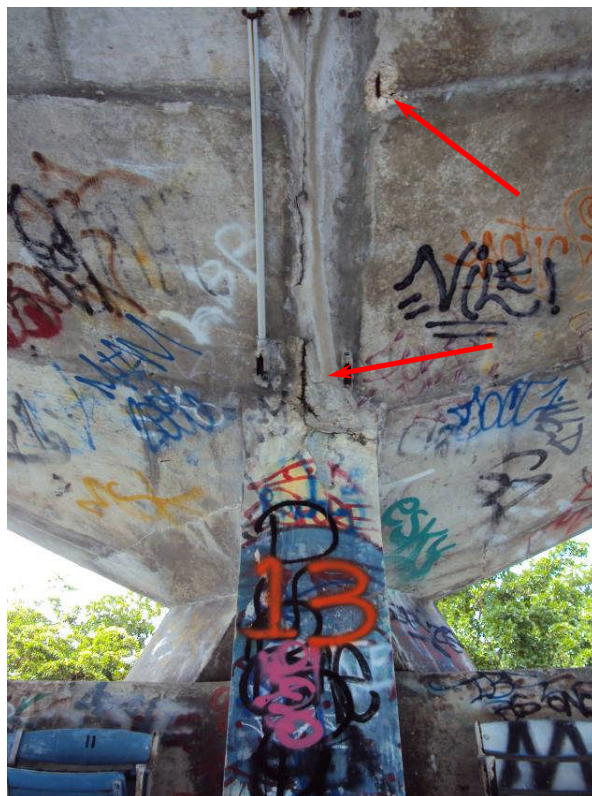
**Photo 29**

Deterioration on bottom side of roof.

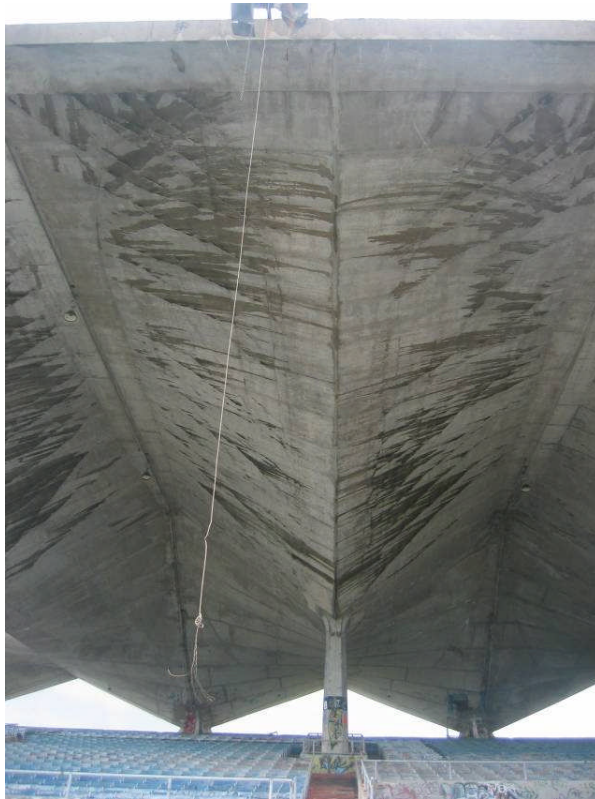
**Photo 30**

Typical cracking of roof hypars (bottom side).

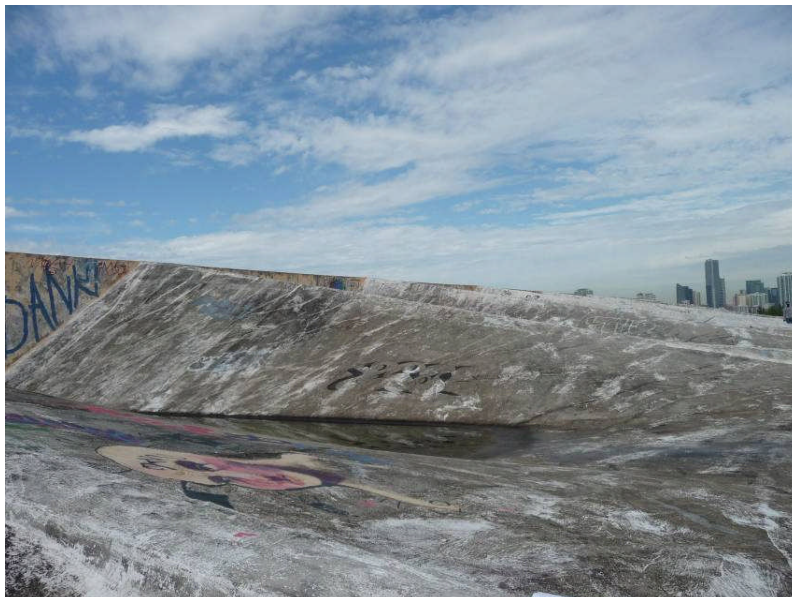
**Photo 31**

Typical cracking of roof hypars (top side).

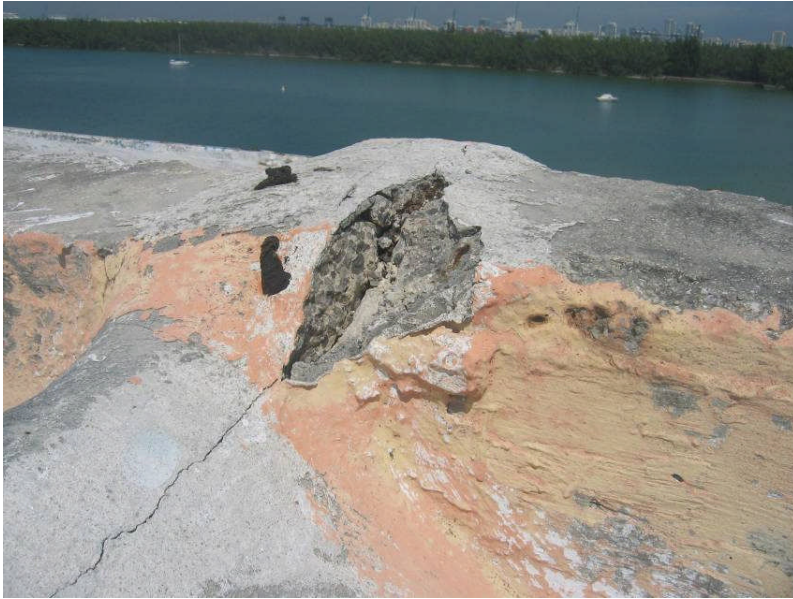
**Photo 32**

Deterioration at post-tensioning anchorage zone.

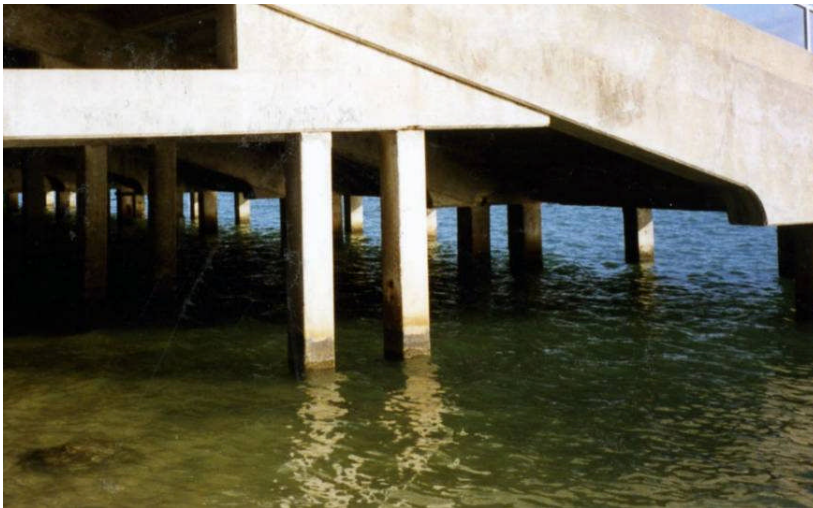
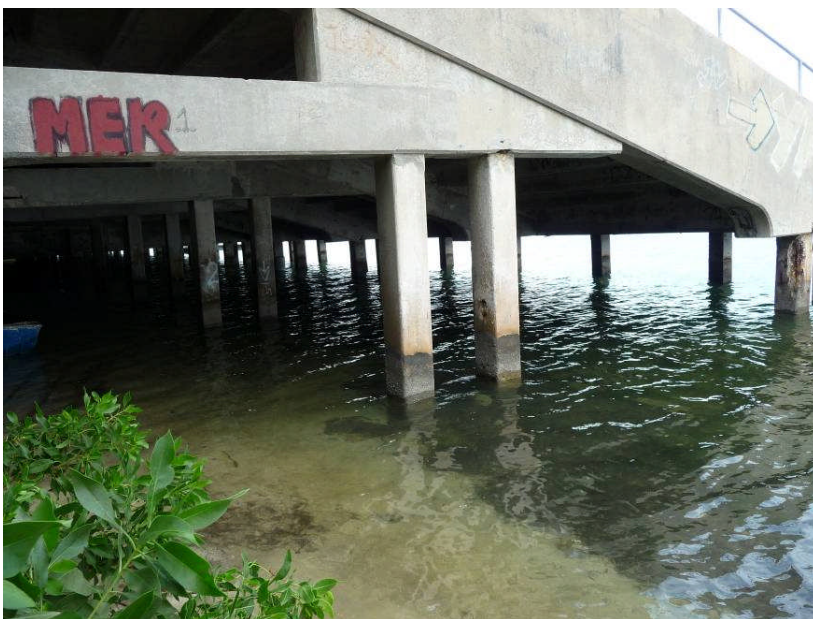
**Photo 33**

Piles F-1 and G-1 not showing significant deterioration growth.

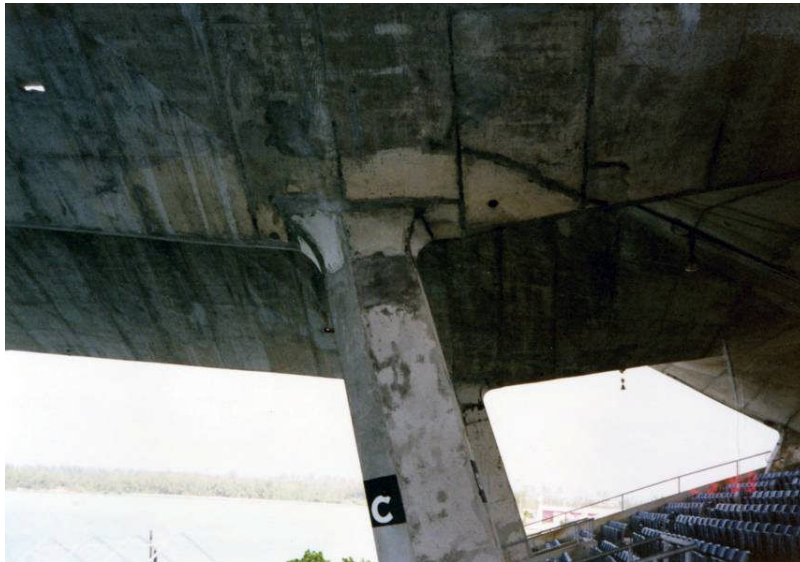
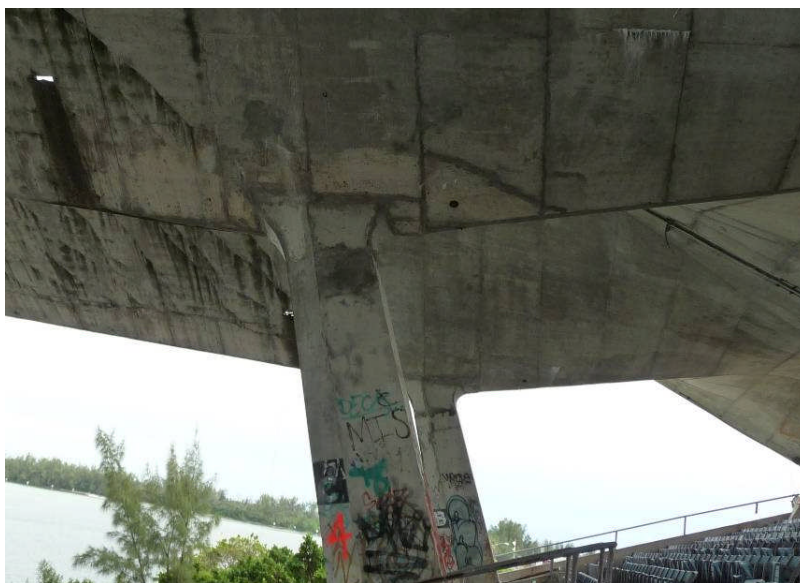
**Photo 34**

Cracking on bottom side of roof near line 4 front slanted column do not appear to have increased.

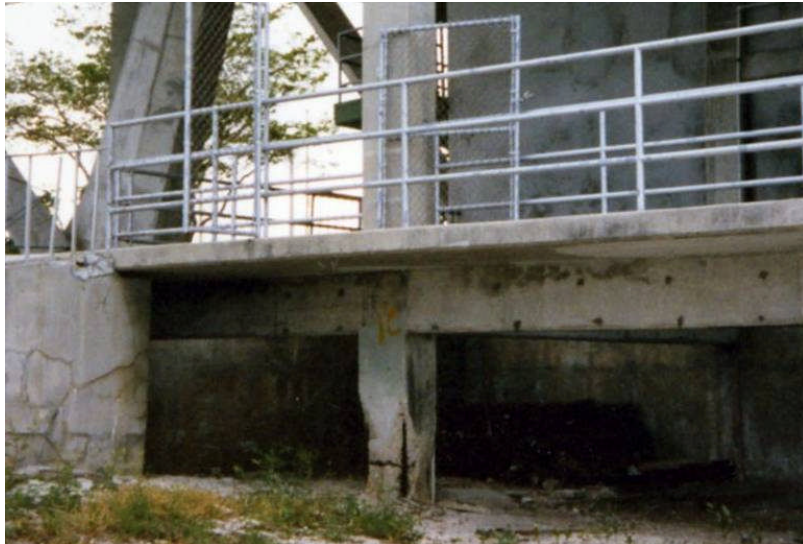
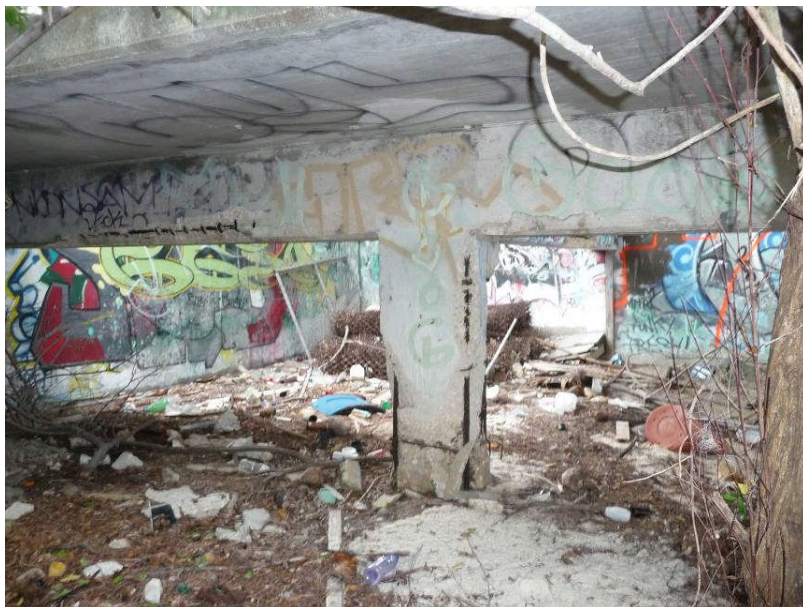
**Photo 35**

Column C-1 showing some growth of spalls.

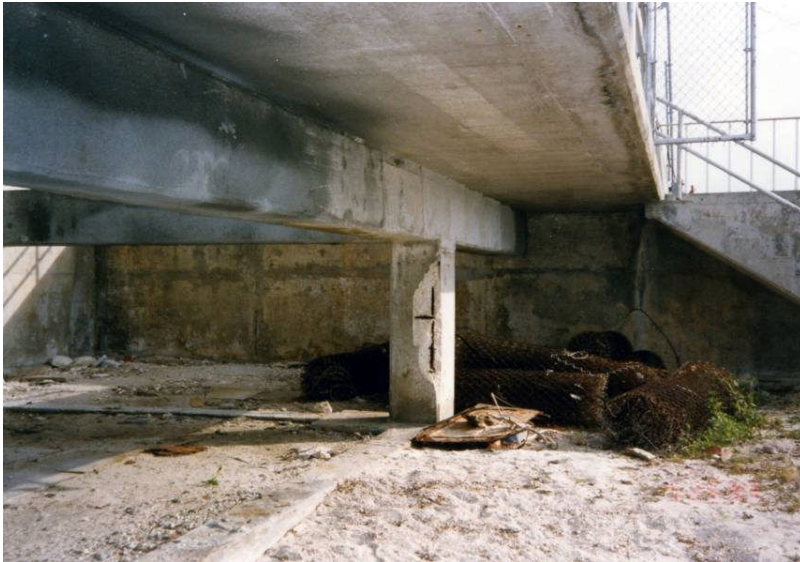
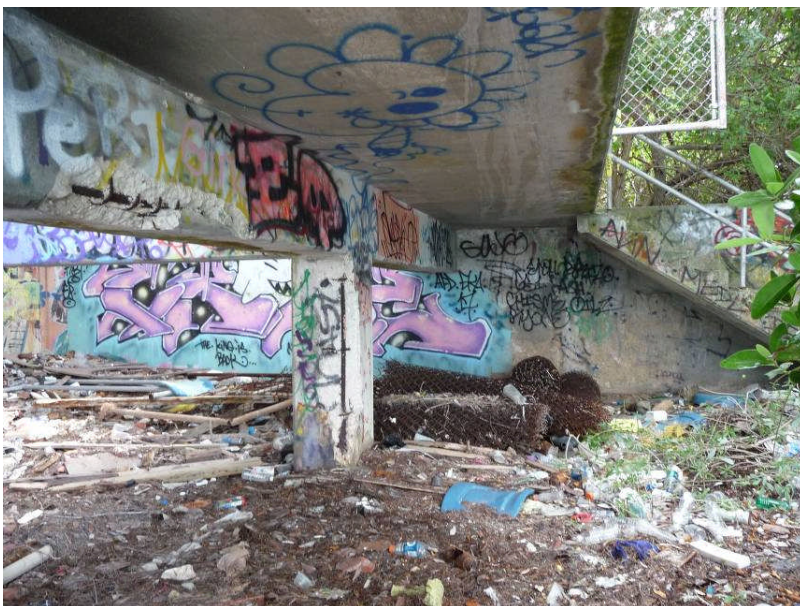
Photo 36

Column C-17 showing some growth of spalls.

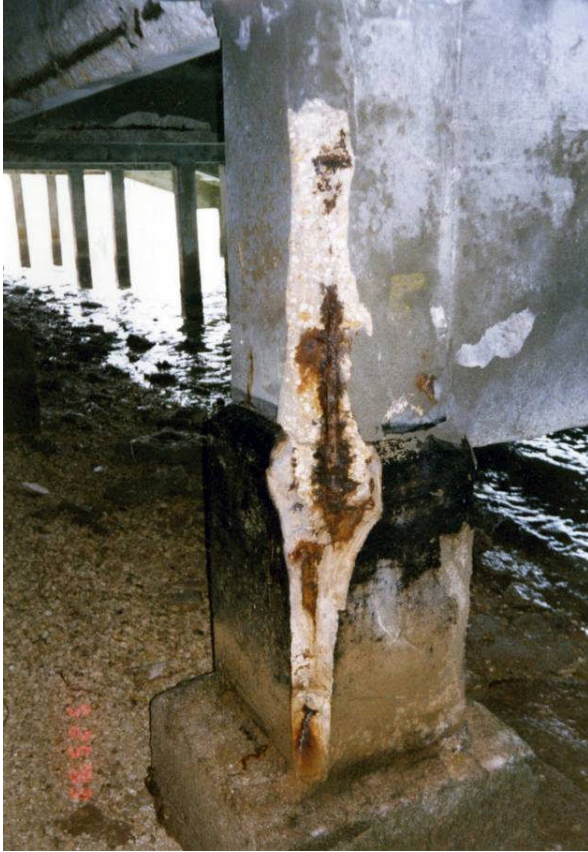
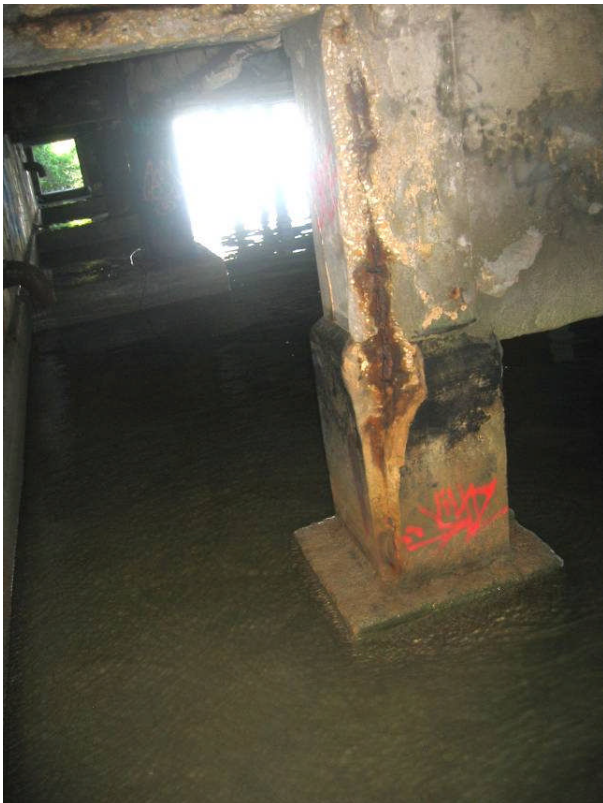
**Photo 37**

Column E-13 showing minor growth of spalls.

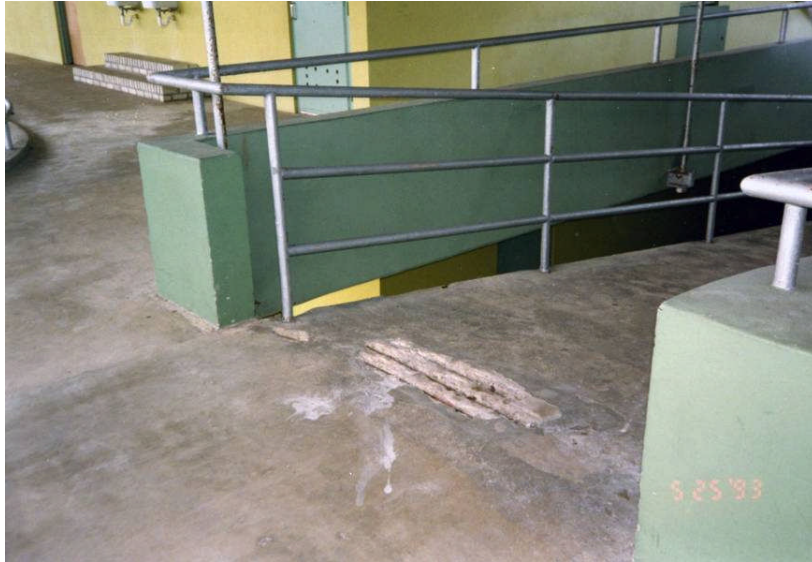
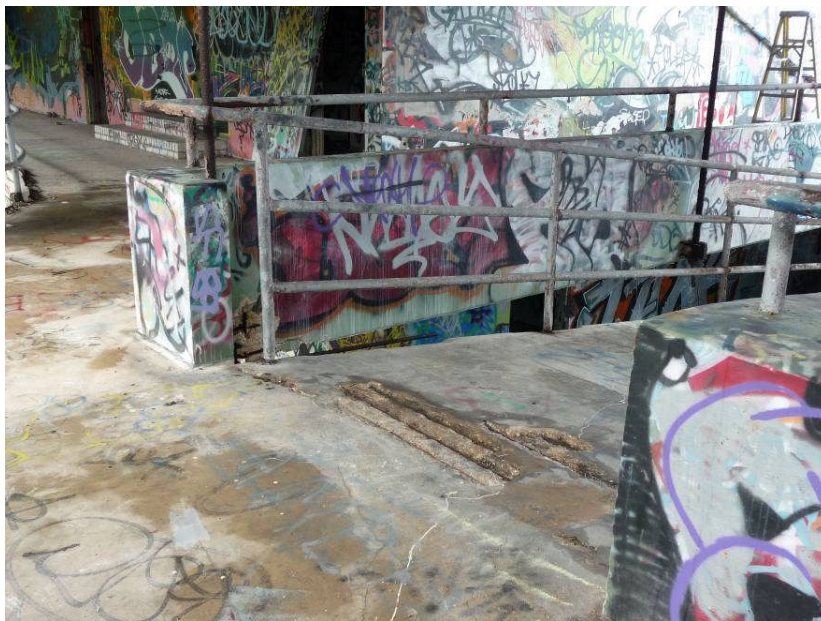
**Photo 38**

Ramp next to column line 5 showing some growth of spalls.
