# Structural Repair and Protection Cost Estimate and Attendant Condition Appraisal of the Miami Marine Stadium

Miami, FL  
January 2010

SGH Project 090457

Project 090457.00 – Structural Repair and Protection Cost Estimate and Attendant Condition  
Appraisal of the Miami Marine Stadium, Miami, FL

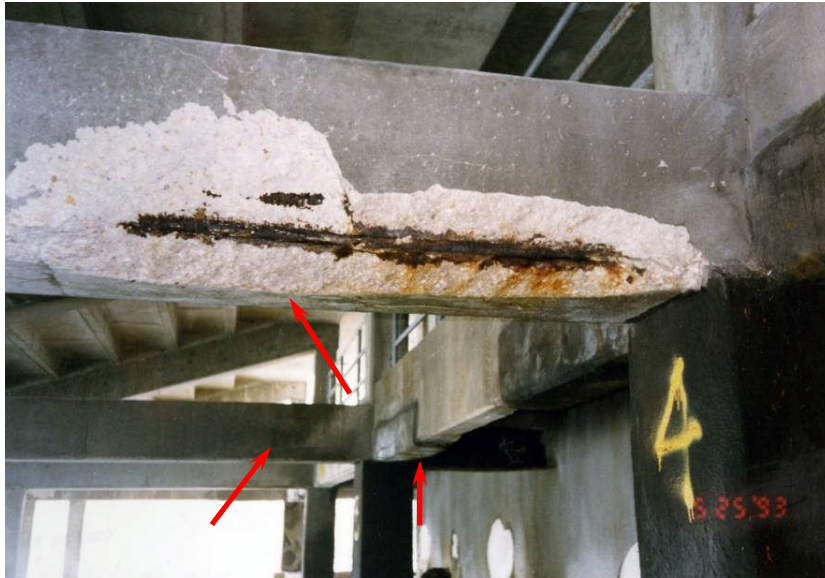
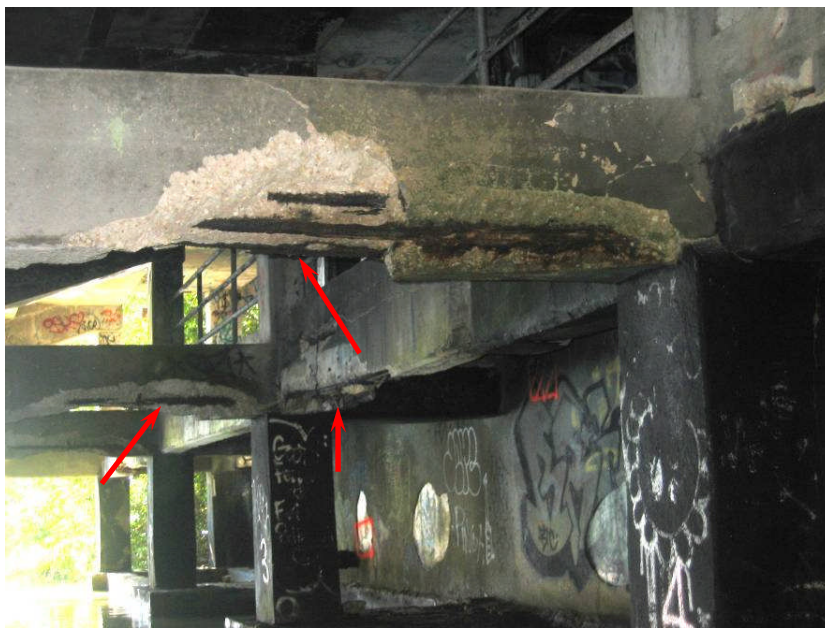
**Photo 39**

Beams over water showing growth of spalls and new spalls.

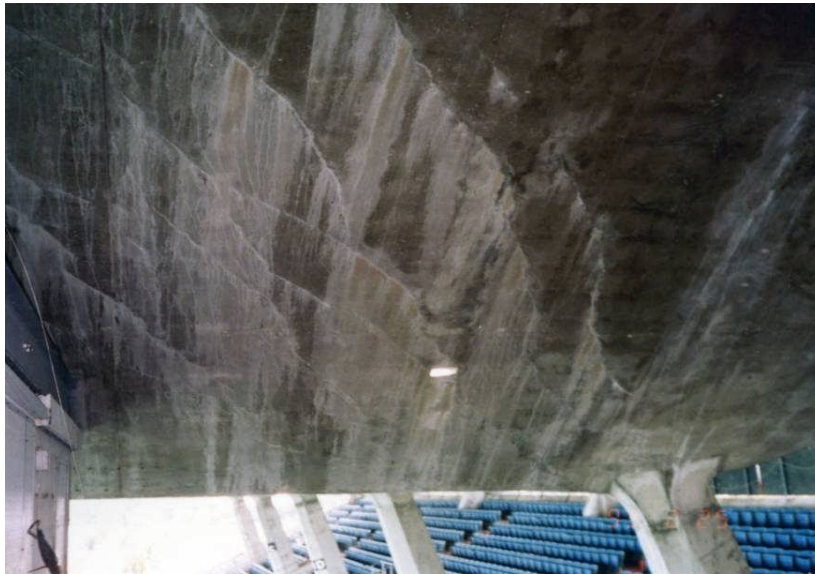
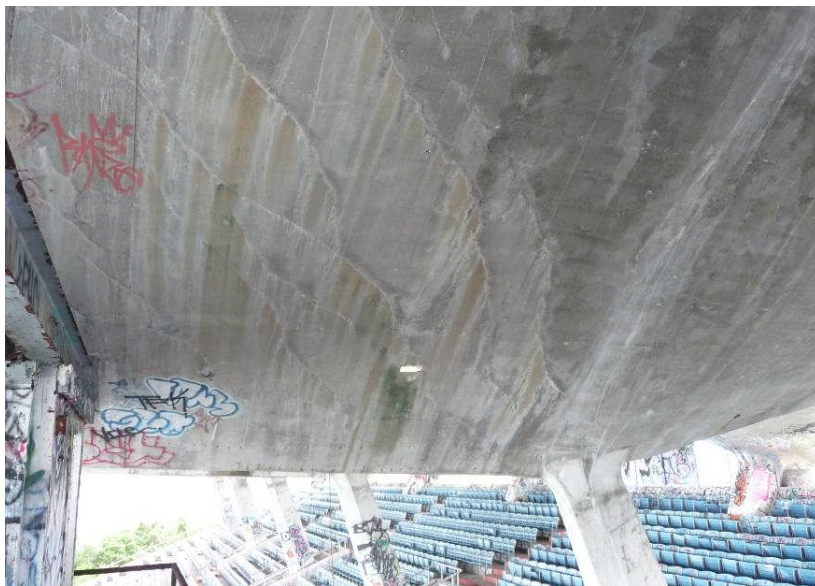
**Photo 40**

Cracking on bottom side of roof near line 12 front slanted column do not appear to have increased.
